THE ACCIDENT TO THE NRX REACTOR ON DECEMBER 12, 1952

W. B. LEWIS

Atomic Energy of Canada Limited
Chalk River, Ontario

Report DR-32

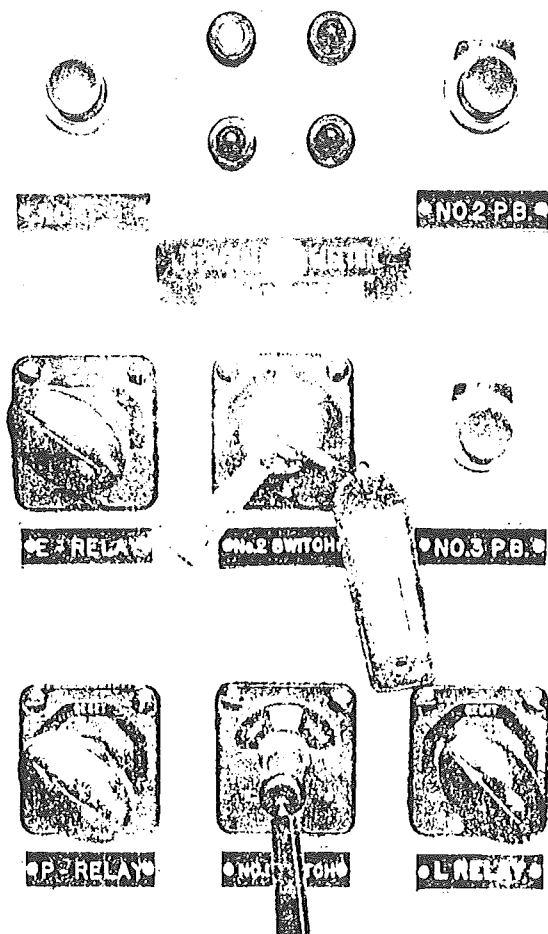
Push buttons 1, 2, and 3 are on the panel shown in Fig. 1, centrally mounted on the control desk.

Fig. 1—Central panel on control desk.

Push button 3 serves to increase temporarily the current through all solenoid magnets in the shut-off-rod head system. This ensures good seating of the air-release valves and also draws the pistons on the shut-off rods fully home. The normal maintained current is adequate to hold the rods and valves in position. Excess current above the minimum would delay release.

To ensure satisfactory operation, push button 3 is pressed in conjunction with push buttons 4, 1, and 2. If it is not pressed with push button 4, air may leak from the head system; if it is not pressed with 1 and 2, the shut-off rods may not be drawn fully home, and safety circuits would prevent the start-up operation from proceeding further.

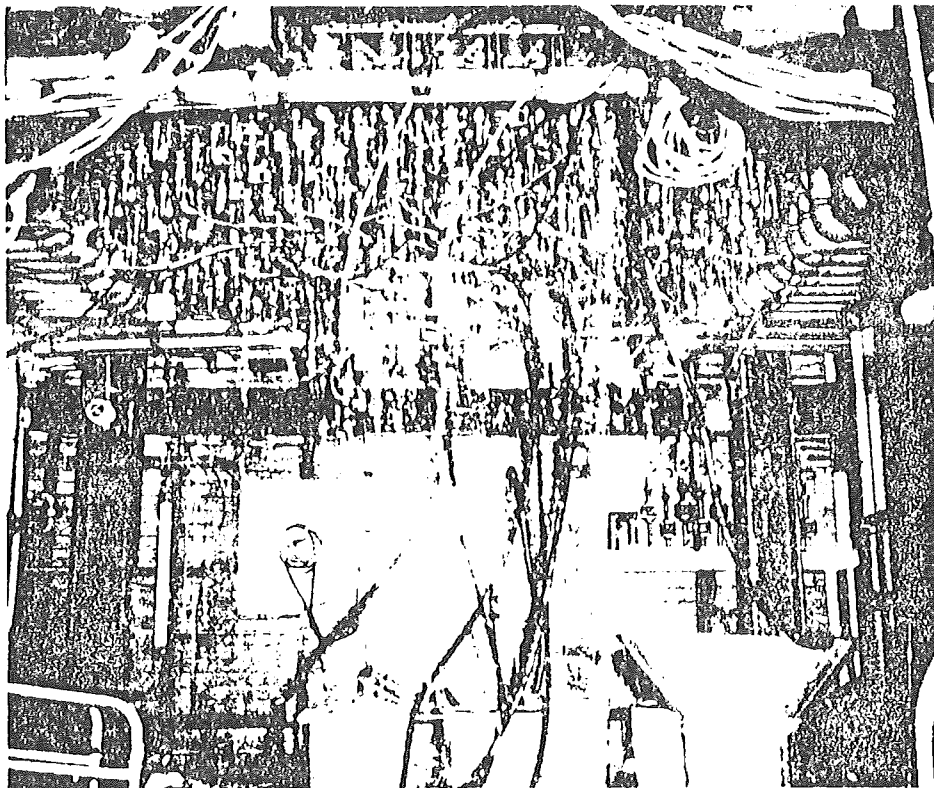
Fig. 4—Lower header room below reactor after the accident with water gushing down.

In the basement the door into the chamber under the reactor (the lower header room) was open. Through this an operator saw water gushing down (Fig. 4), and immediately he called the supervisor. Their instant reaction was to suspect any water as being heavy water; there-

fore the supervisor and operator rushed in with a bucket and collected a sample, which was soon found to be light water but radioactive.

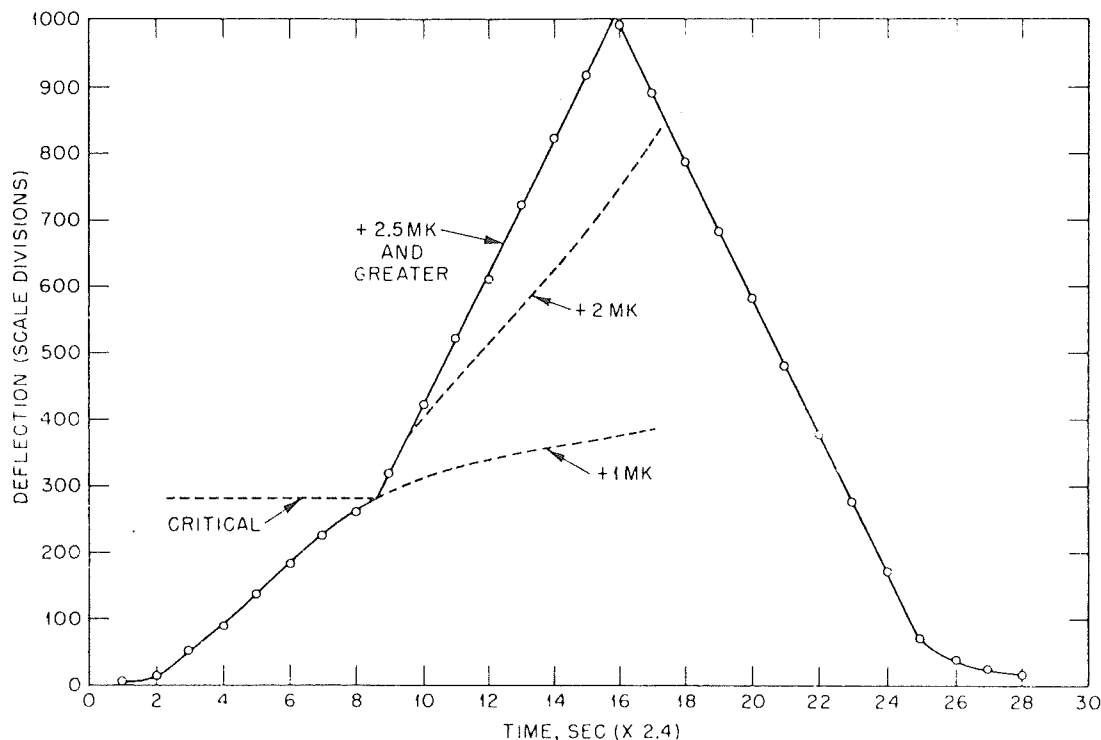
a good graph could be made of instrument reading against time. This is shown in Fig. 5.

greater, the recorder ran at its maximum rate. The estimate that the reactor power did not exceed 90 megawatts (on the scale of this instrument) is based on the observation that a sufficient overload signal would jam the indicating galvanometer and the recorder would remain at full-scale deflection. This did not occur in the incident as shown by Fig. 5.

Fig. 5—Expanded trace of power recorder during the power surge with transients from simulator superposed. (Time scale is in units of 2.4 sec., the interval between successive balancings.) —, NRX transient. ---, reactor simulator transient.
